West Valley Sanitation District Sanitary Sewer Smoke Testing

Draft Submittal: July 2018

V&A Project No. 17-0162

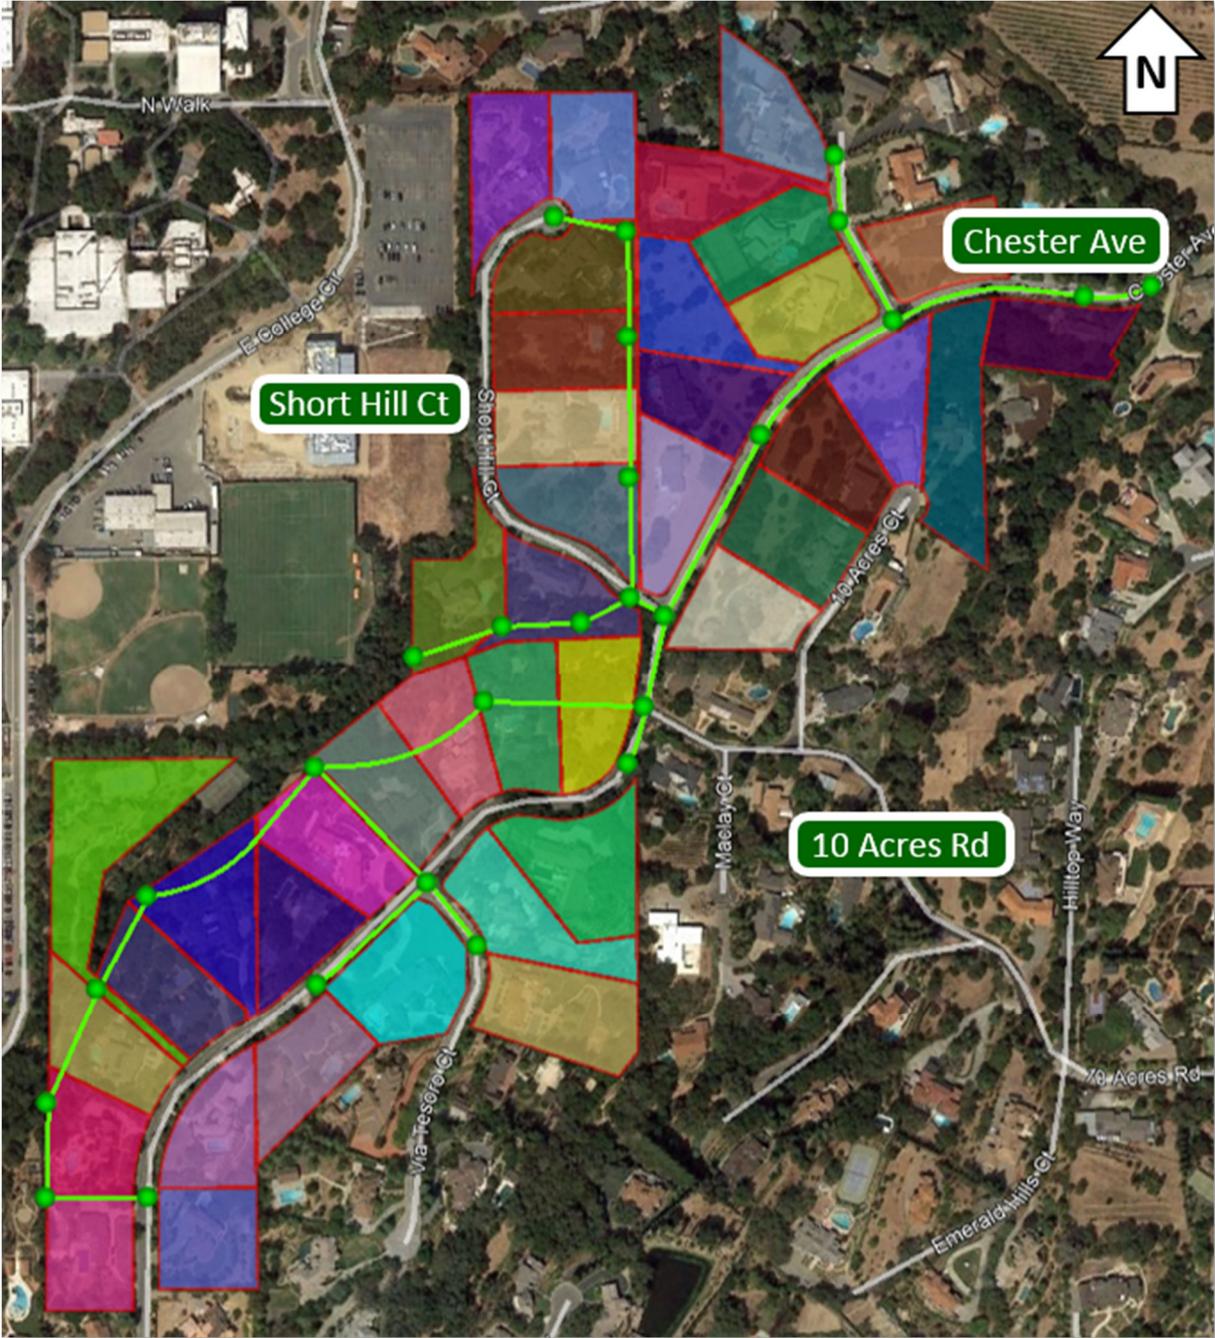
Figure ES-1. Map of Area of Testing

V&A Consulting Engineers, Inc. (V&A) has completed sanitary sewer smoke testing for West Valley Sanitation District (District). Testing was performed on June 19, 2018 in Basin 10 of the District's collection system (Figure ES-1). Flow monitoring was performed in this basin during the 2016 wet weather season as a part of the District's ongoing flow monitoring program. Monitored as Site E10 (see report titled 15-0210 West Valley Sanitation District FM and II Final Rpt'), this basin ranked 2nd in Inflow out of 15 monitored basins during the flow monitoring study.
